*Phase I Environmental Audit  
Blair Backup Property  
Port of Tacoma, Washington*

*Prepared for  
Port of Tacoma  
Tacoma, Washington*

*October 9, 1989  
J-2350-01*

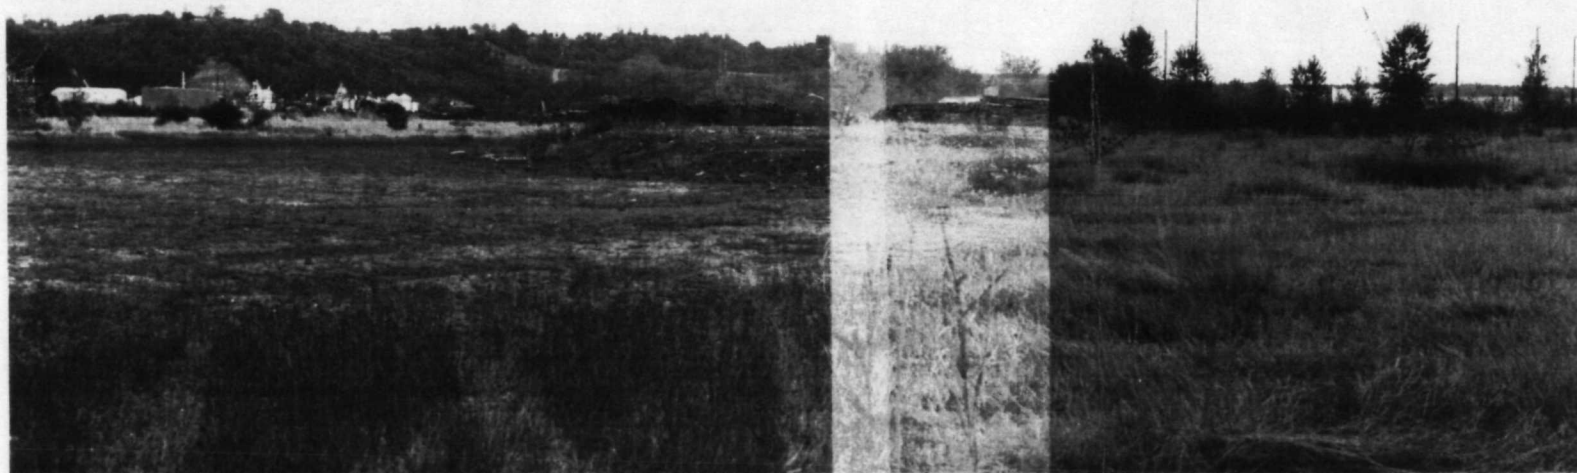
Photograph 1 - Recent fill and area of seasonal ponding (November 1988).

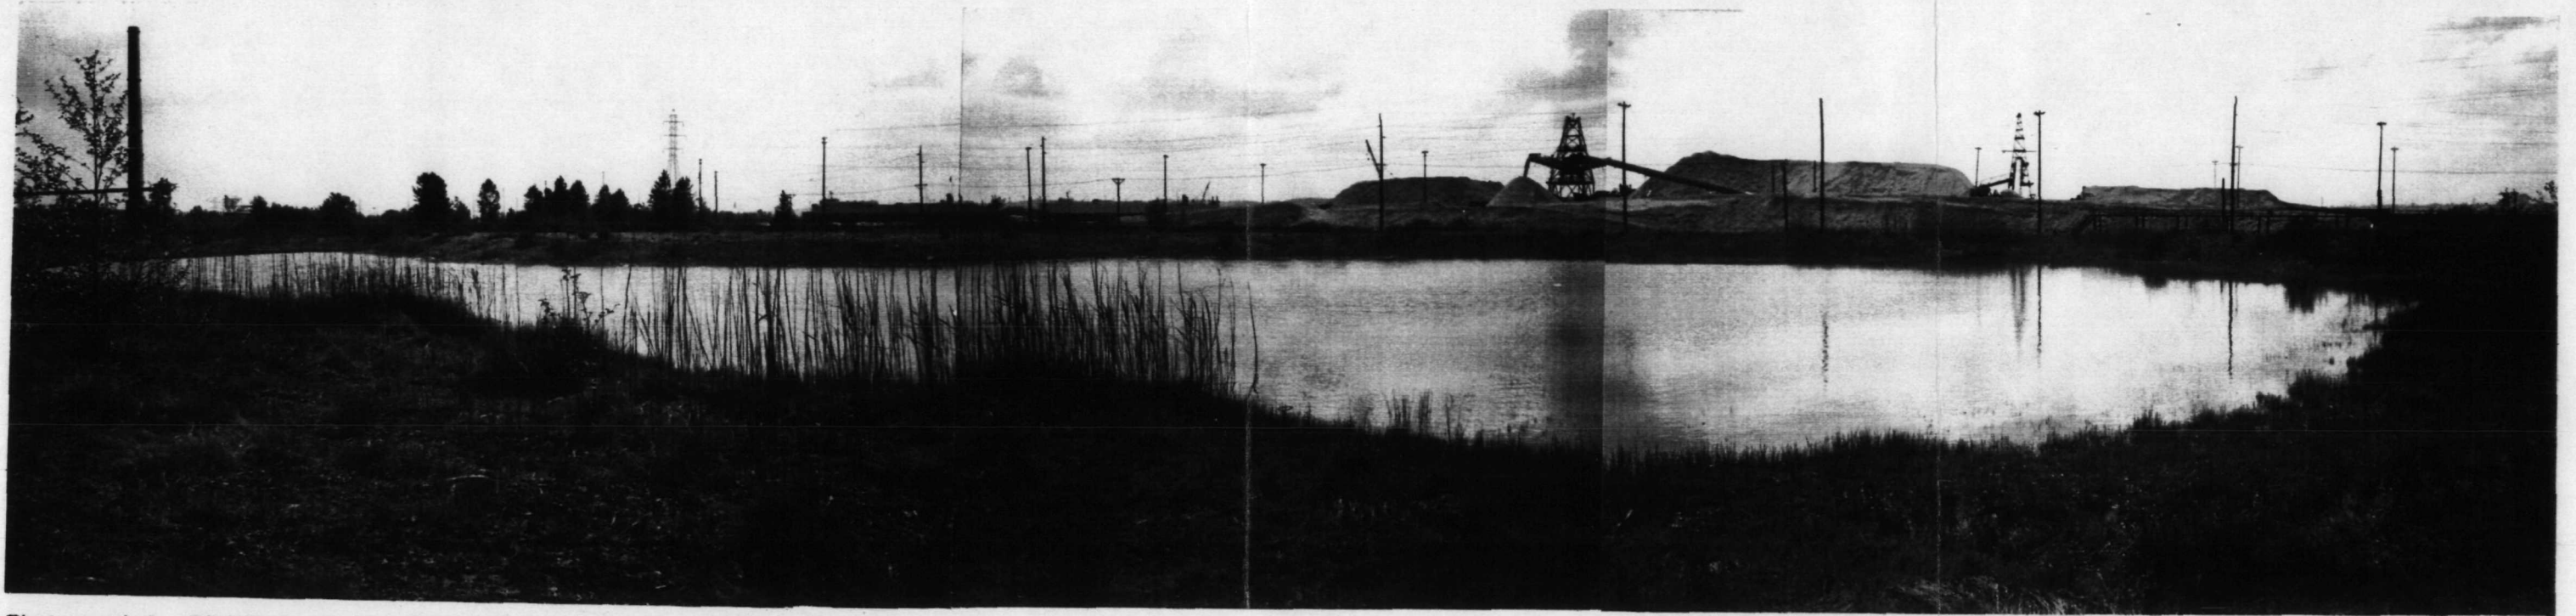
Photograph 2 - Blair back up: Poned water in area (May 1989) detailed in Photograph 1.

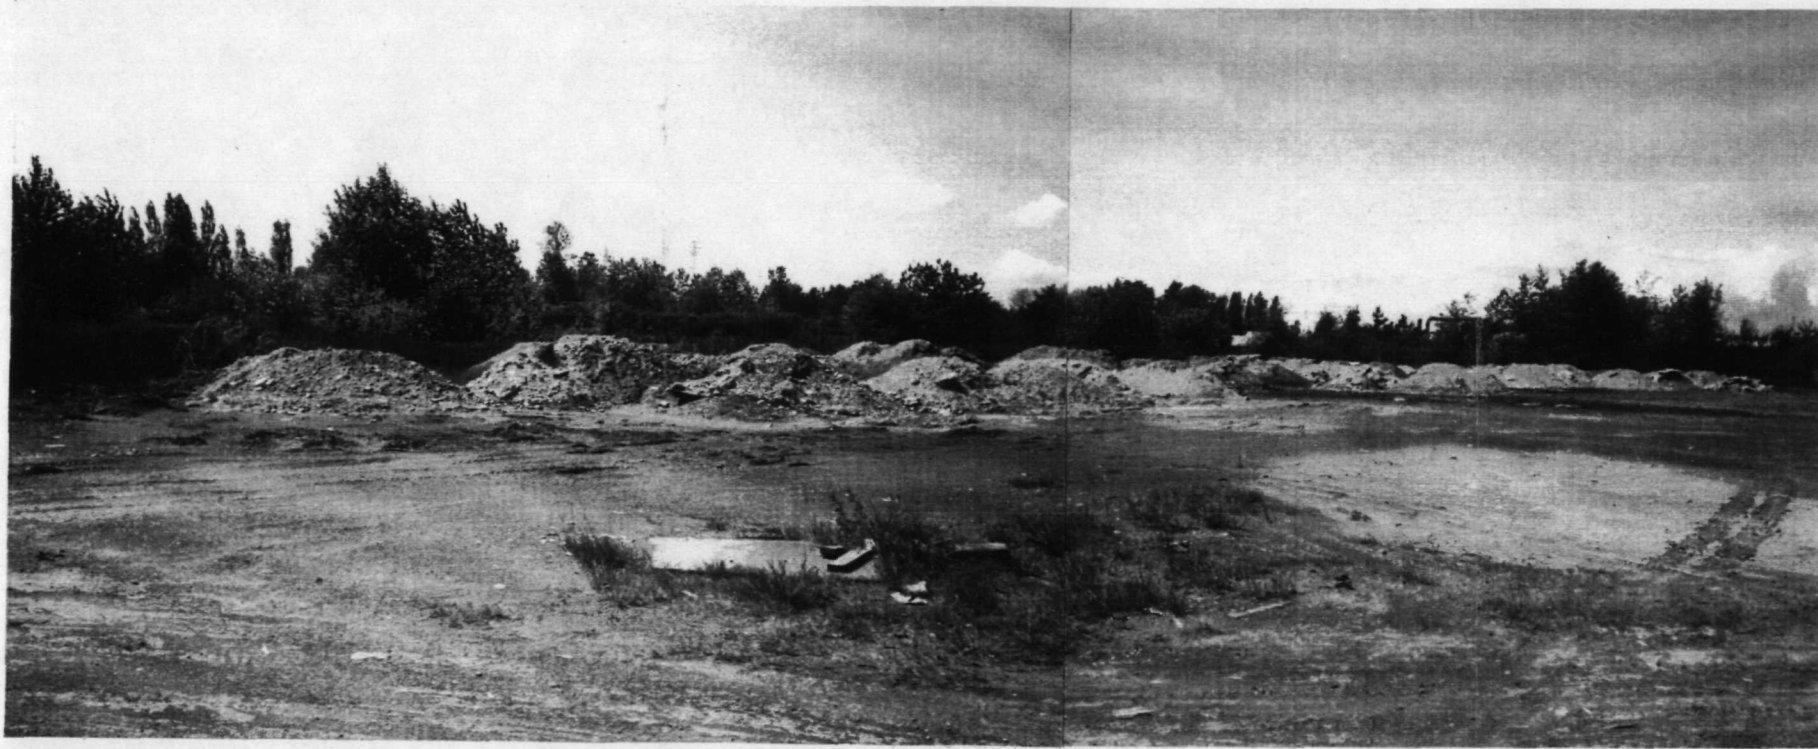
Photograph 3 - Blair back up: Construction debris and rubble fill material.

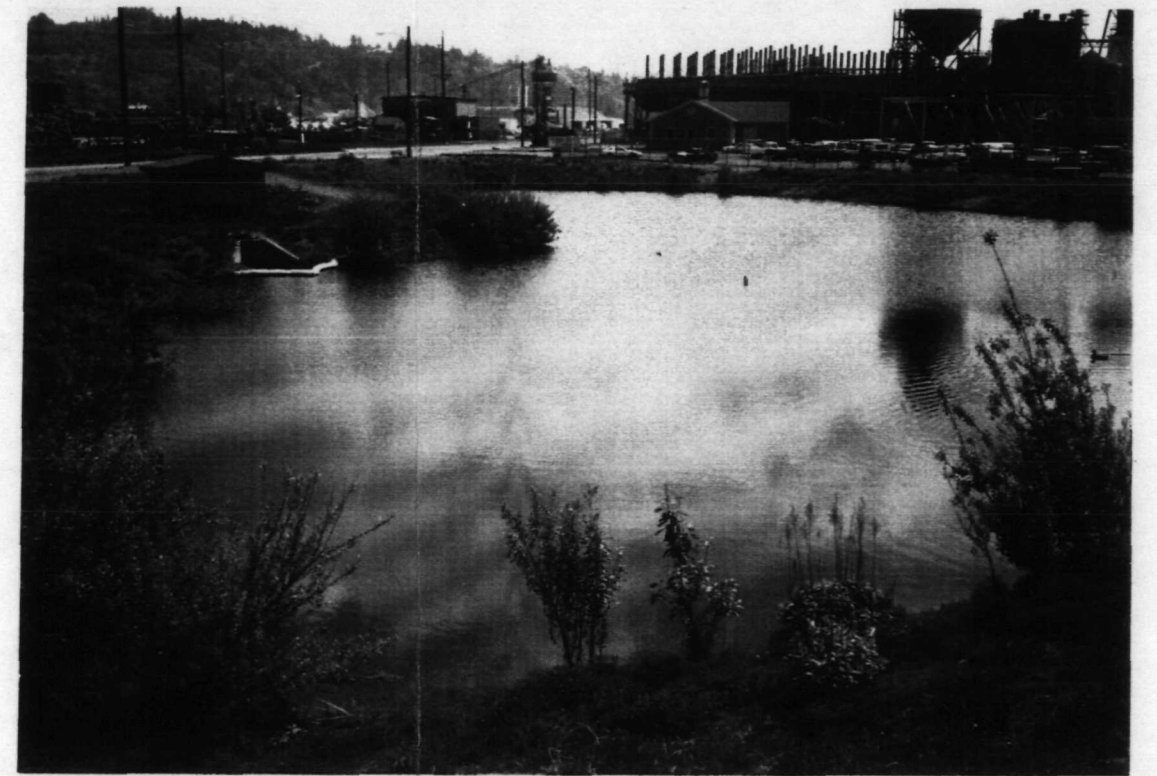
Photograph 4 - Blair back up: Lagoon area in eastern corner of Blair back up.

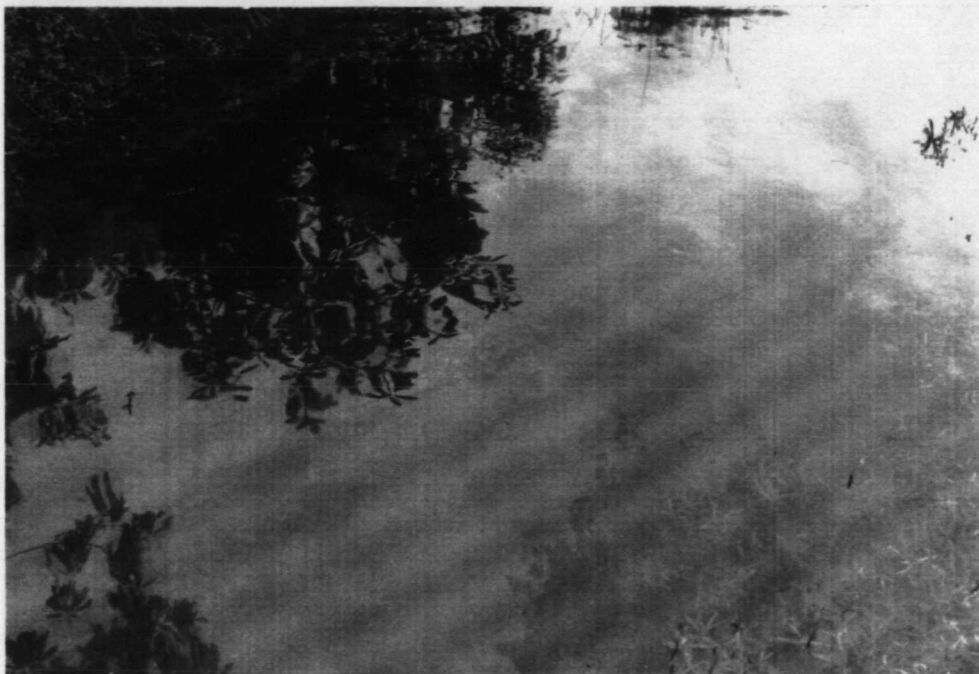
Photograph 5 - Oil sheen in ditch.

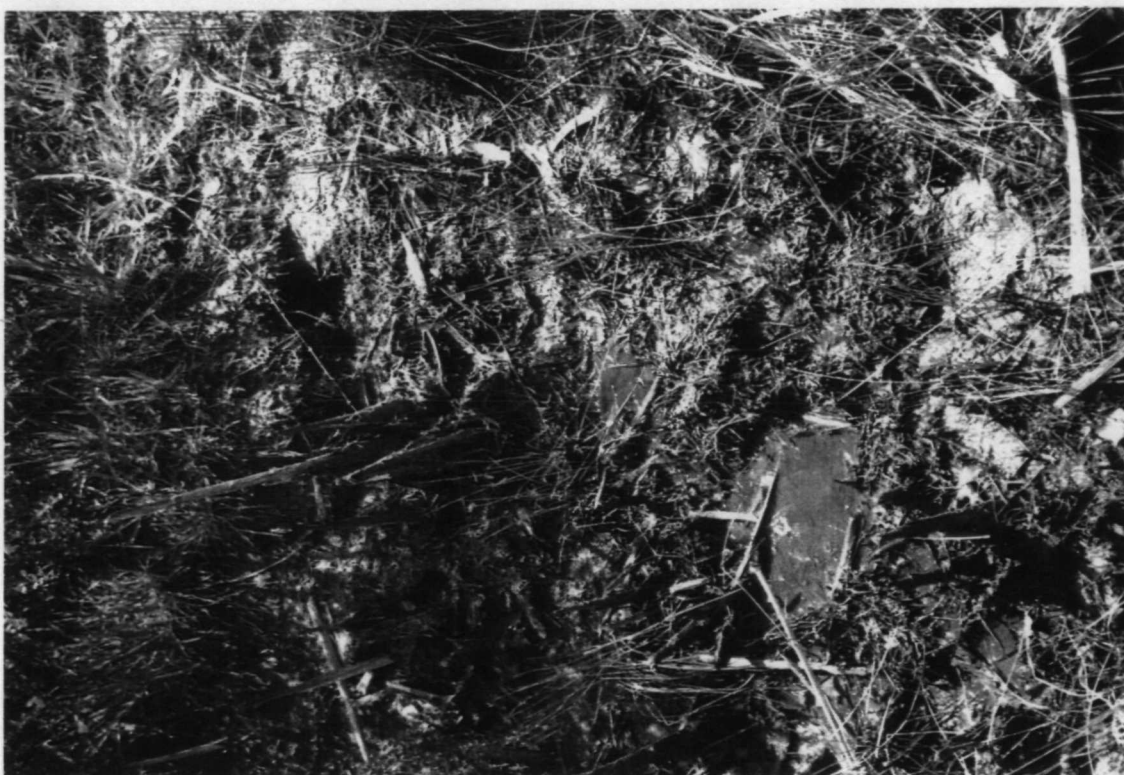
Surface water from the site drains via a series of drainage ditches. These ditches generally enter culverts to cross under Alexander Avenue or Taylor Way and drain to the Blair or Hylebos Waterways. The property near Reichhold generally drains to the Blair and the property near Kaiser generally drains to the Hylebos. The ditch running along the property boundary with Reichhold Chemical has been sampled (CH2M Hill, 1989B). A summary of the chemical results are given earlier in this report. During our site visit in November 1988, we observed substantial oil sheening on the water in the ditch (see Photograph 5). During subsequent site visits, we did not observe as much sheen. On at least one area along the banks of the ditch, discolored (white) soil and possibly waste material are evident (see Photographs 6 and 7).

Photograph 6 - Blair back up: Area along ditch, seep.

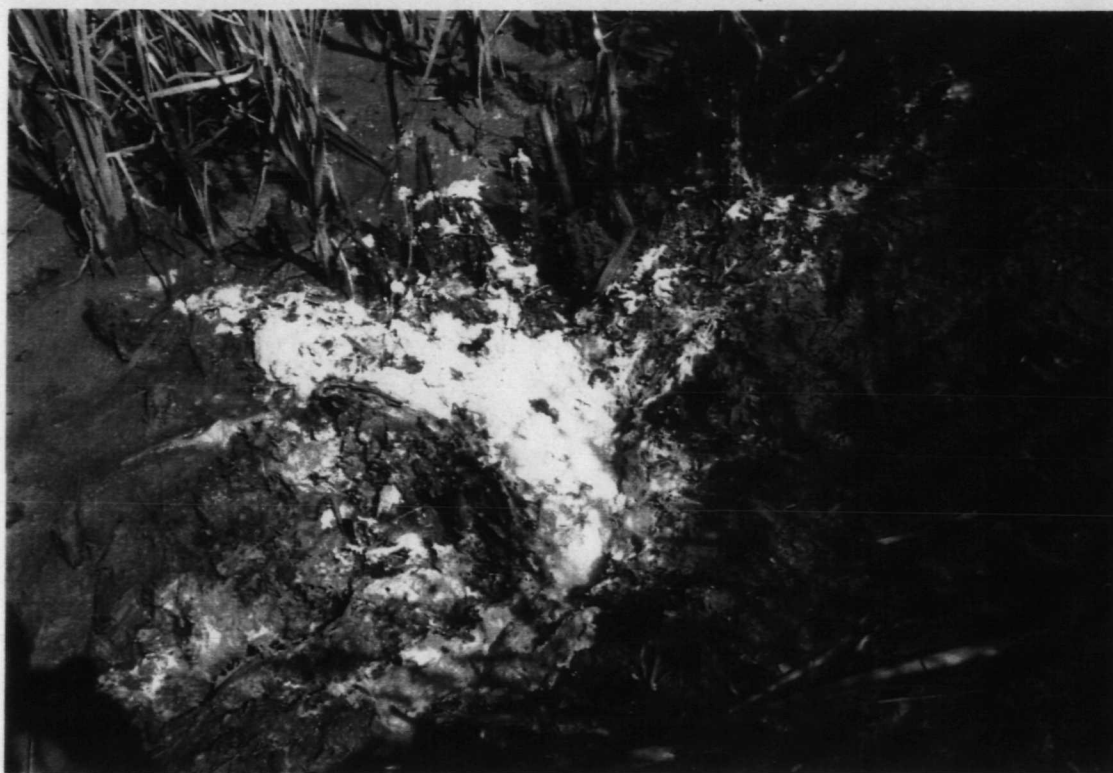
Photograph 7 - Blair back up: Area along ditch, white material disturbed in sediment near seep in Photograph 6.

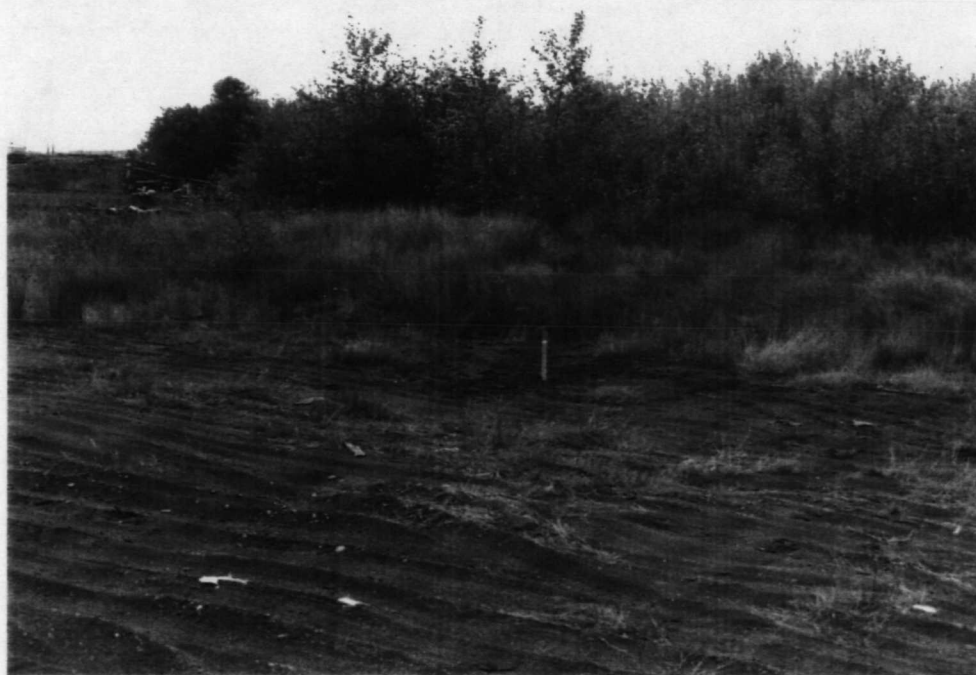
Photograph 8 - Green soil.

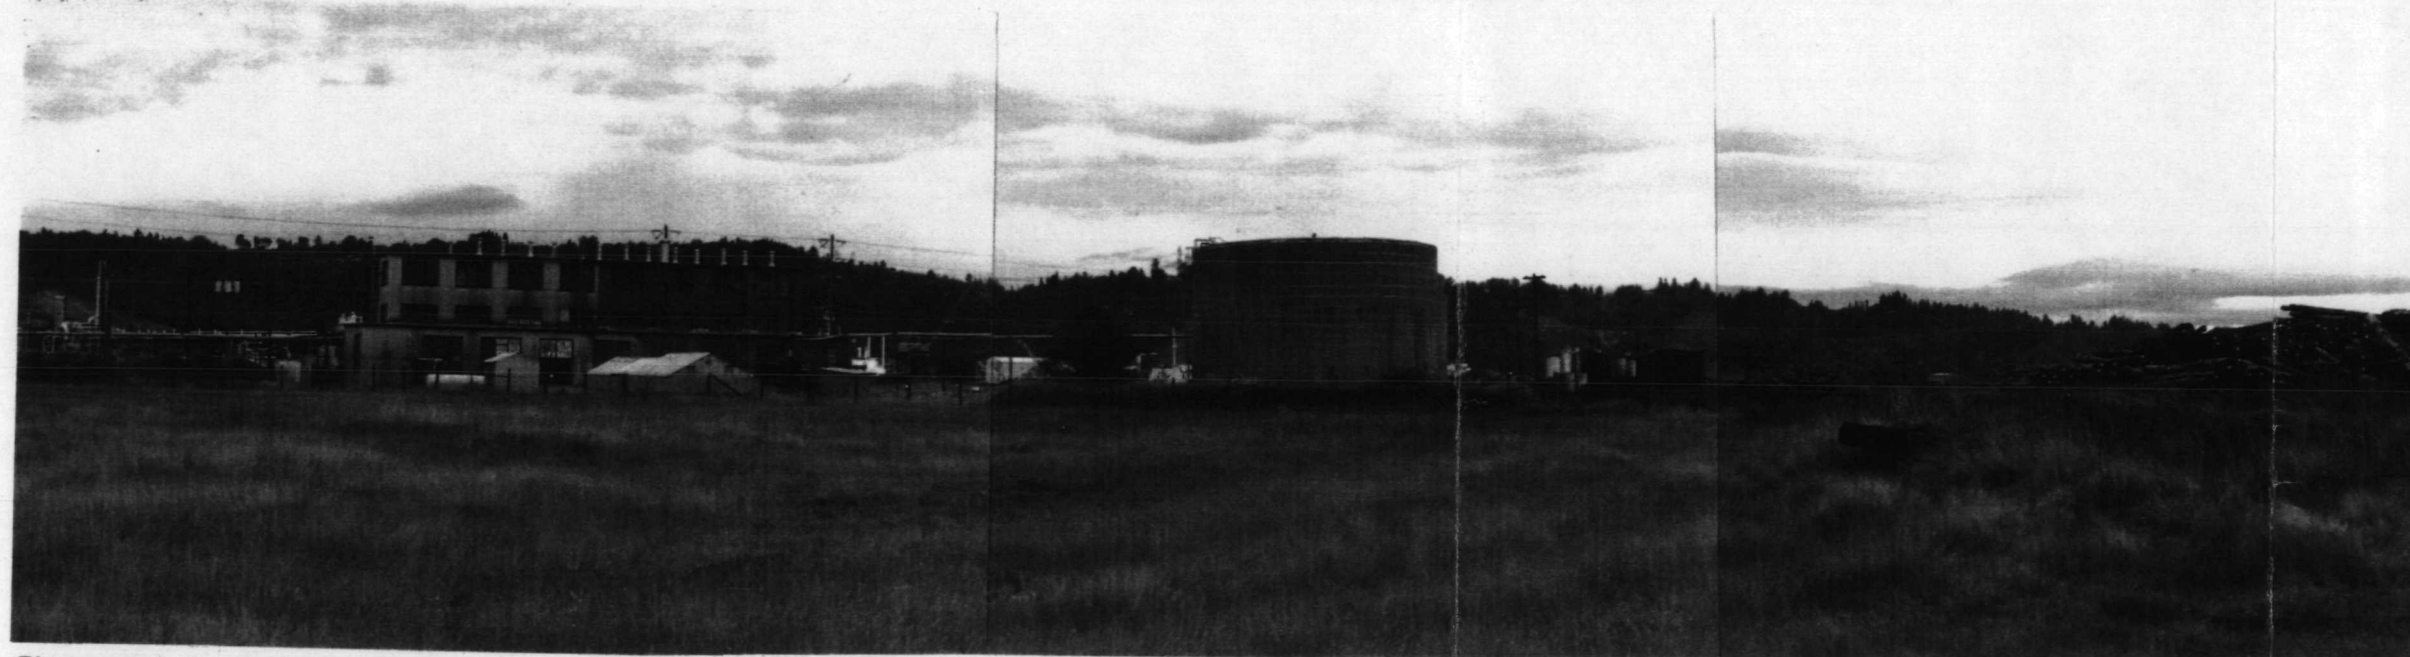
Photograph 9 - Above-ground storage tanks adjacent to property.

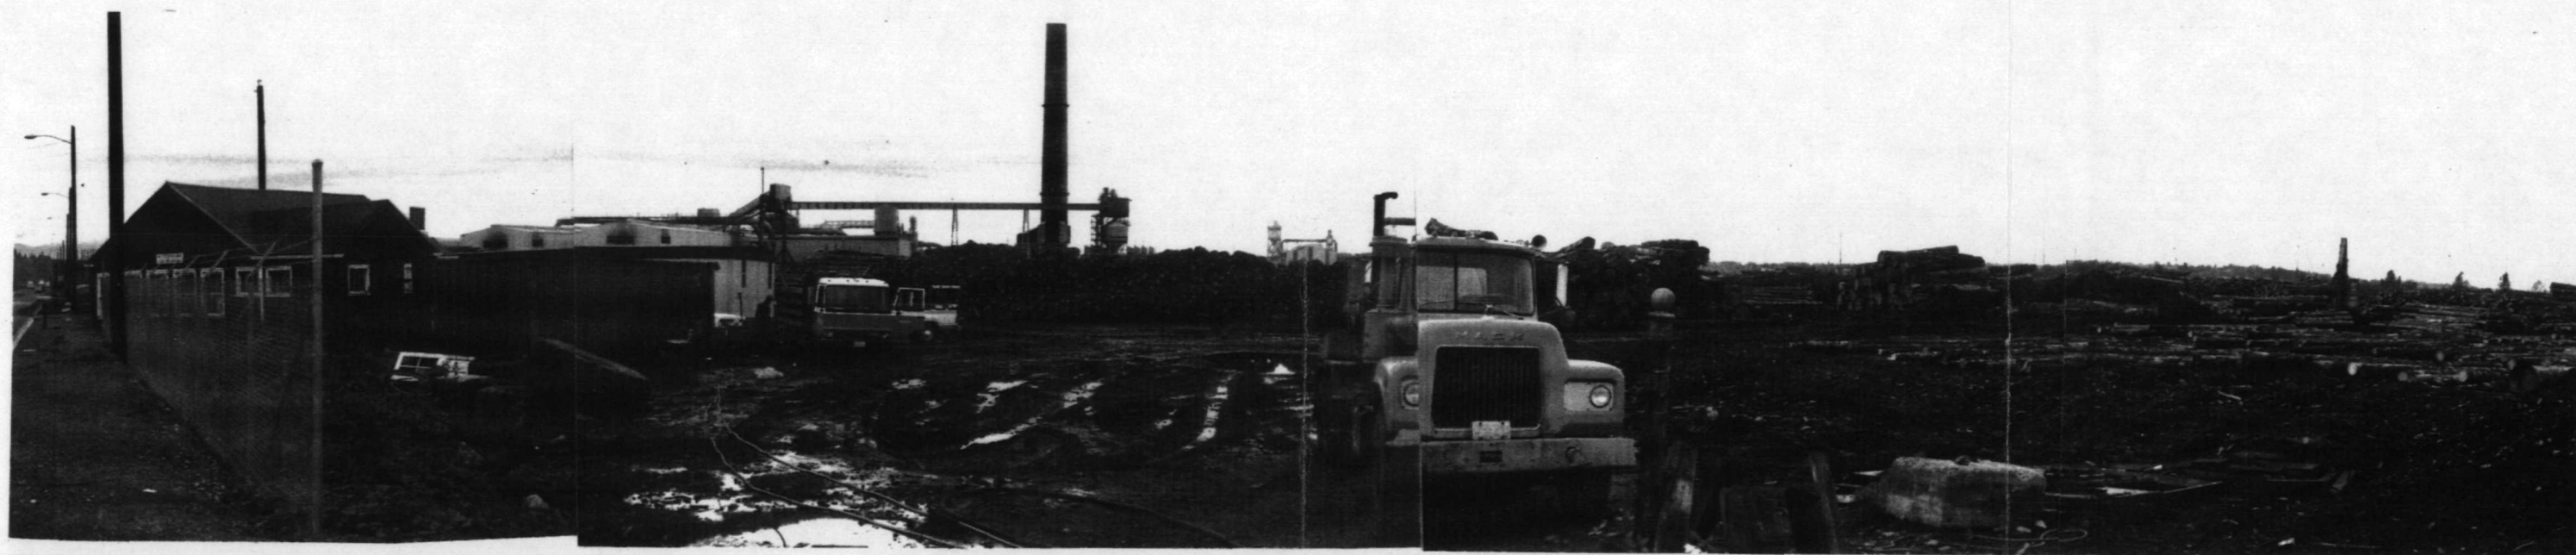
Photograph 10 - Log storage yard.

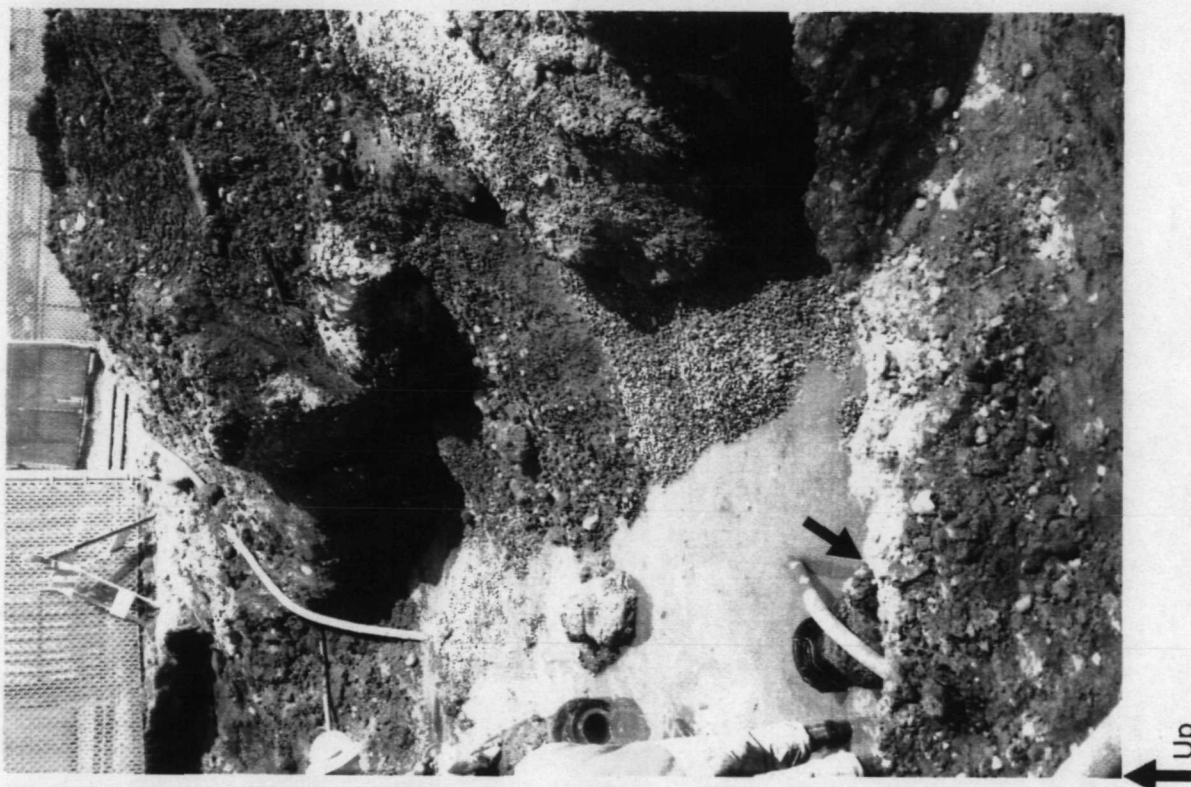
During the May 1989 site reconnaissance, an excavation was observed in progress across Taylor Way from the Blair Backup Property. A City of Tacoma Water Department crew was digging up and replacing a waterline (Photograph 11). A conversation with the foreman of this crew determined that a groundwater seep was entering the excavation pit from a southwesterly direction through a concrete pipe which traversed Taylor Way in the direction of the project property. The concrete pipe serves as a conduit for the water main. The foreman indicated a brown liquid (Photograph 12) had been seeping into the pit from the conduit for over a 24-hour period. A field test of the liquid using pH paper indicated a pH of 12. This finding suggests a potential groundwater contamination from alkaline material in the vicinity of the Blair Backup Property.

Photograph 11 - Off-site Construction: Northeast of Blair back up on Taylor Way. Arrow details close-up area in photograph 12.

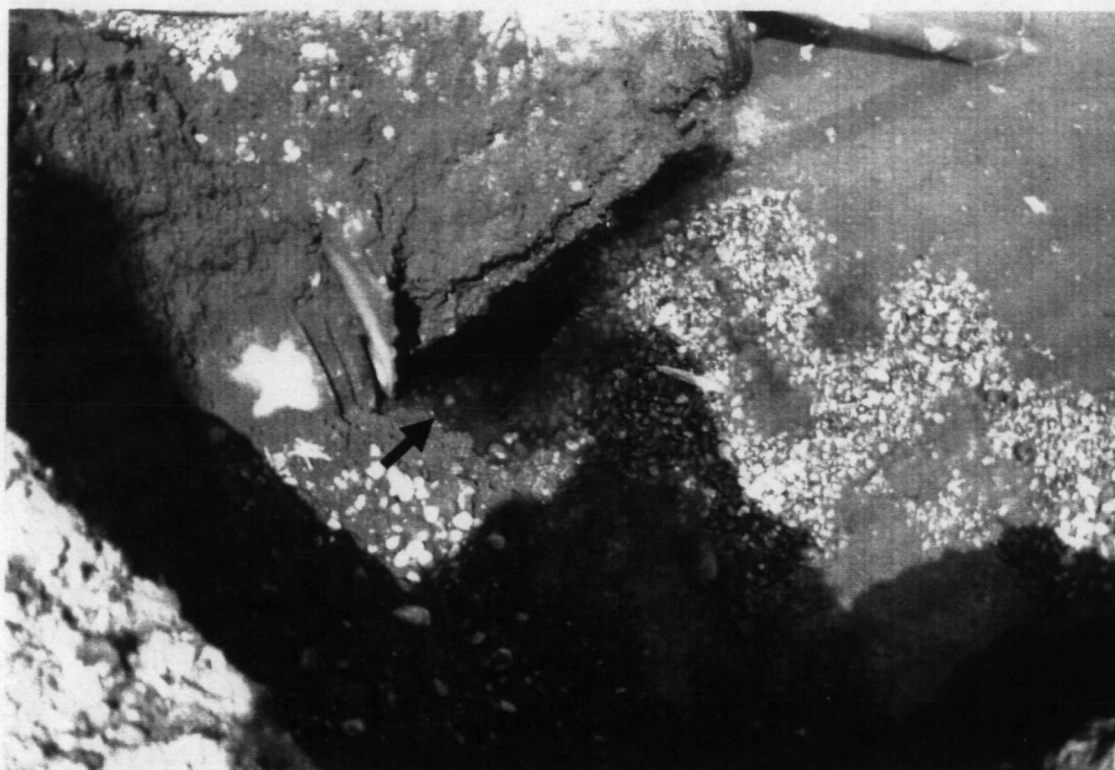
Photograph 12 - Off-site Construction: Northeast of Blair back up on Taylor Way. Arrow shows groundwater seep. Material shows ph of 12 using litmus test strip.

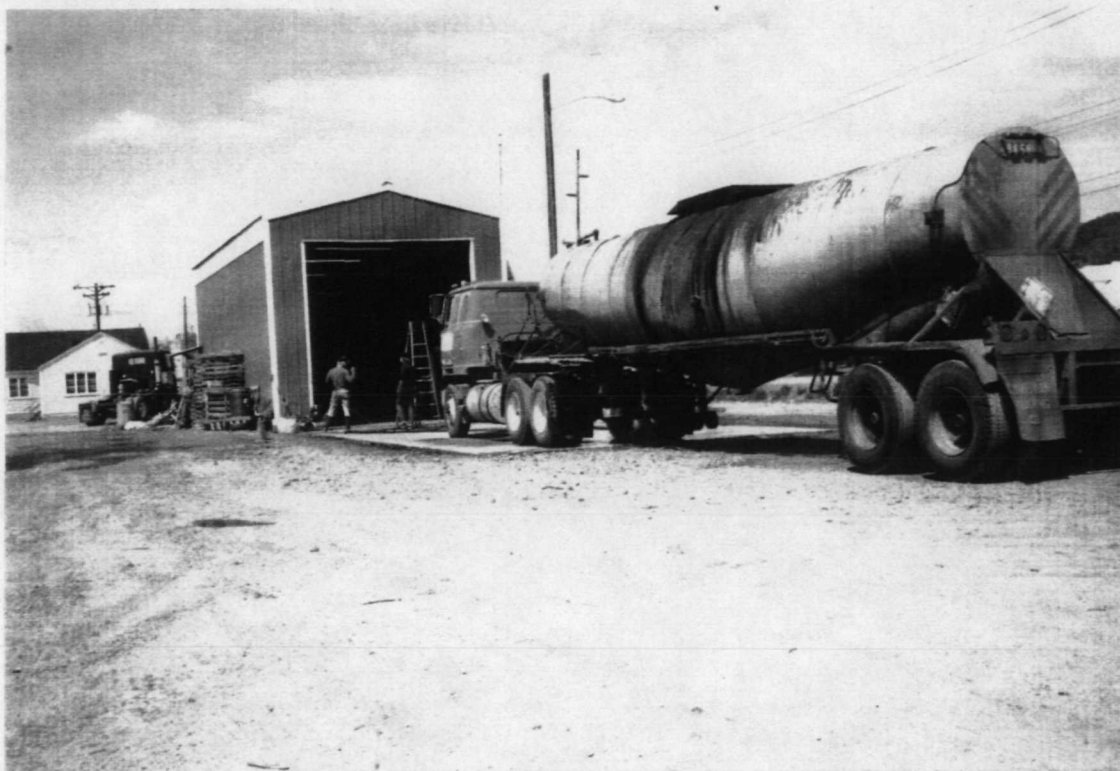
The current occupant of the northern part of Blair Backup Property is operating a steam-cleaning and maintenance area (Photograph 13). Runoff from this area has caused surface soil staining. The staining may be indicative of oil accumulations.

Photograph 13 - Steam cleaning trucks, soil areas visibly stained.

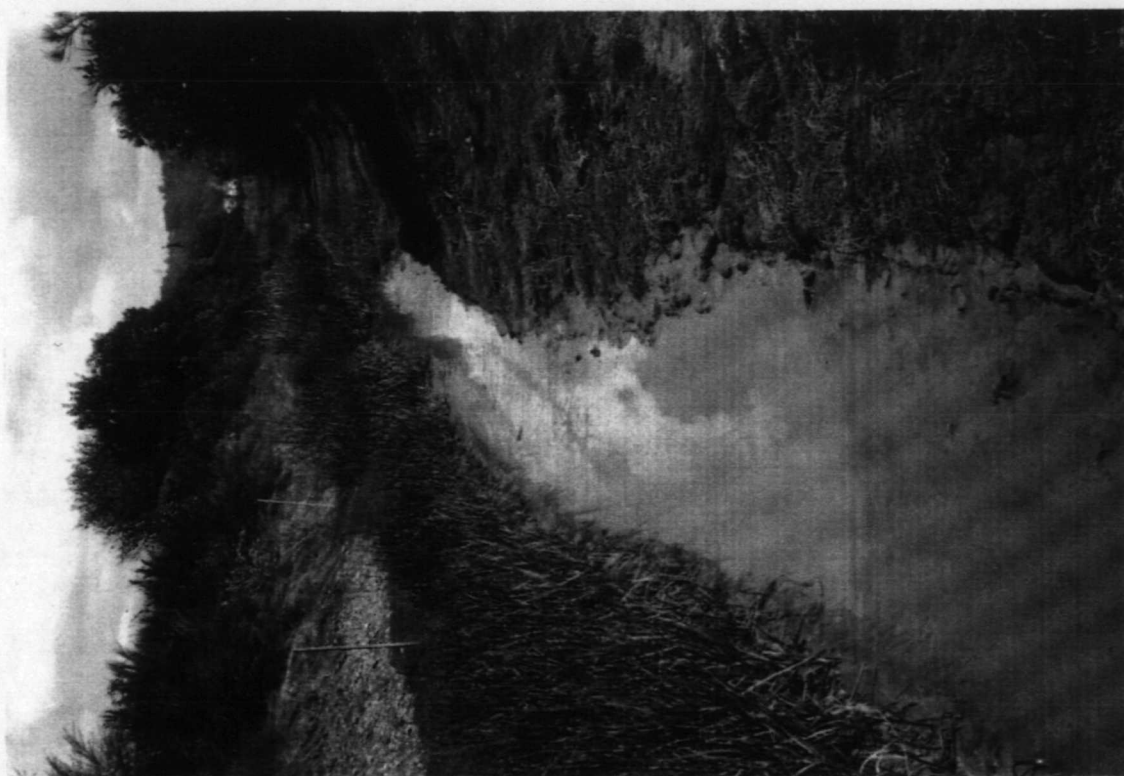
Photograph 14 - Blair back up: Ditch draining property.

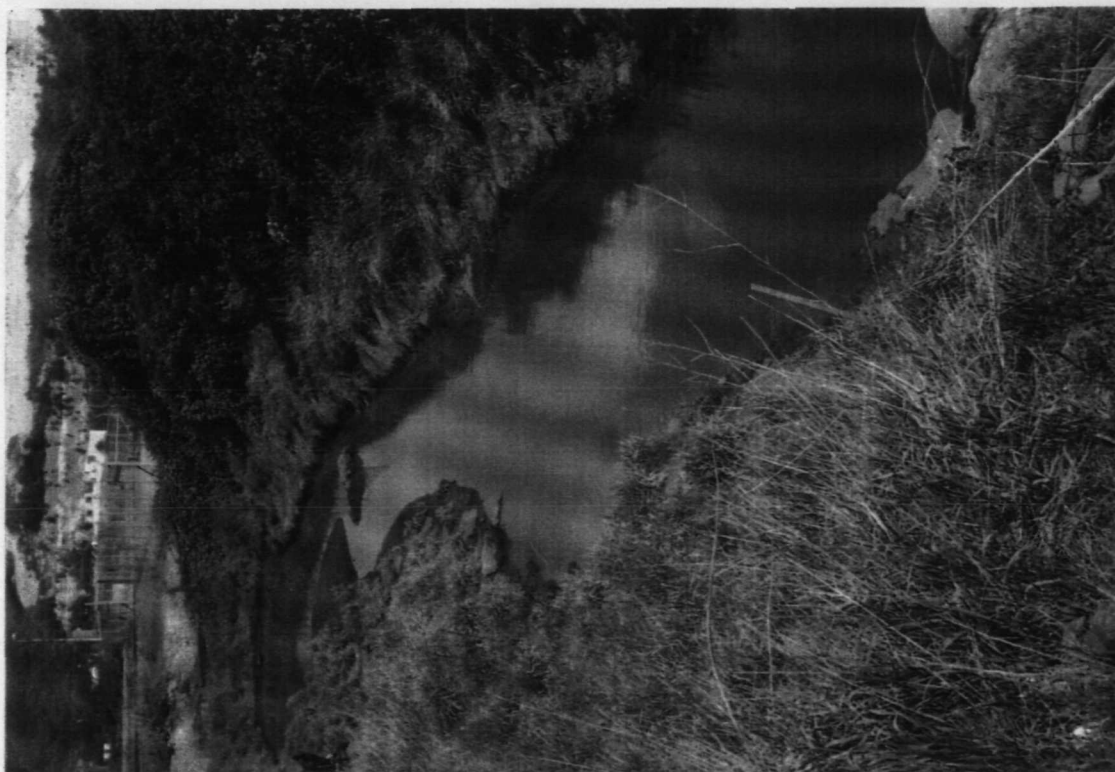
Photograph 15 - Blair back up: Settling basin/low area for ditch (Photograph 14) draining property which travels through pipeline.

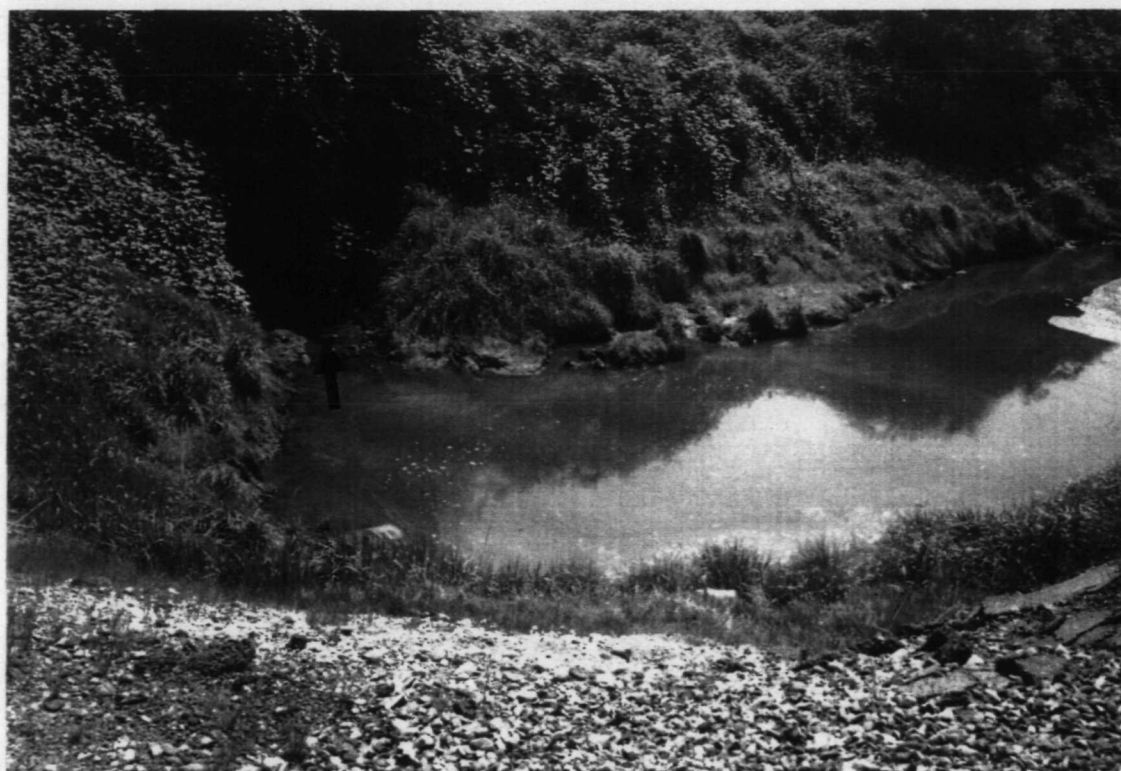
Photograph 16 - Blair back up: Settling basin/low area for ditch draining property. Arrow shows connection with drainage ditch/pipeline.

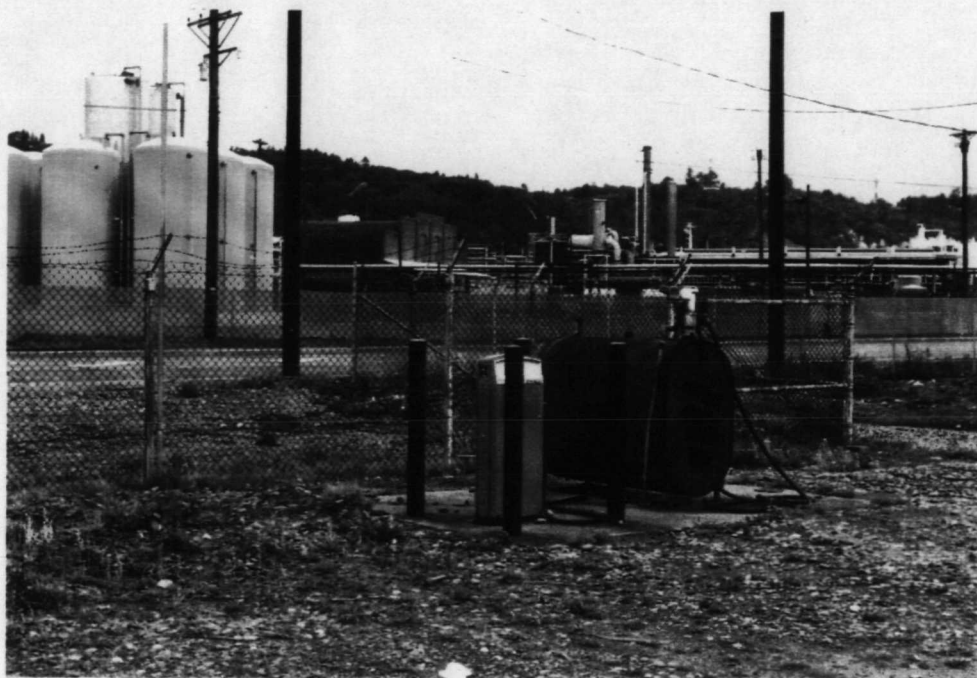
Evidence of an underground fuel storage tank was observed on the northern portion of the site (see Photograph 17). The age, size, and exact contents of this tank are currently not known.

Photograph 17 - Underground and above-ground tanks.
